# The Clay Research Group

Monthly Bulletin

# Aldenham Data Update

August 2006.

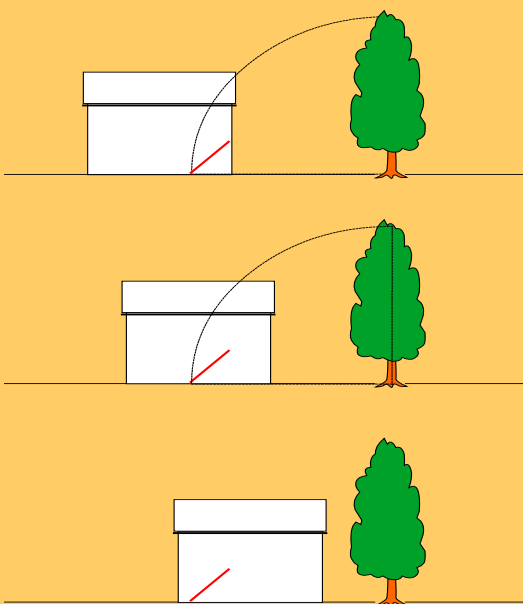
Take a look at the examples above. The "crack to tree" ratio has been fixed, and 'D' is different in each.

Our study (see following page) shows that by far the most relevant measure is the distance to the approximate line of crack propagation, which is usually around 1.2 x tree height.

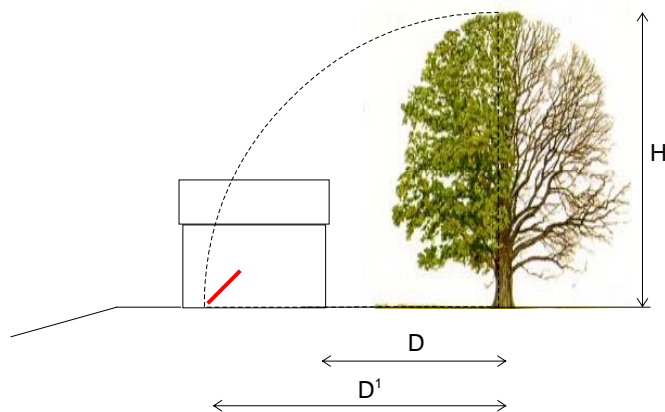
As we suggested on the previous page, the distance between the tree trunk and the building isn't the best way of determining tree root influence and risk zones, although it is of course a starting point.

Take the example where a long wall starts say 1mtr from the tree trunk and cracks appear 4mtrs away. The H/D value is largely meaningless.

It would appear from our study that the real zone of root influence is best determined by measuring to the base of the crack - this is the fulcrum of movement.

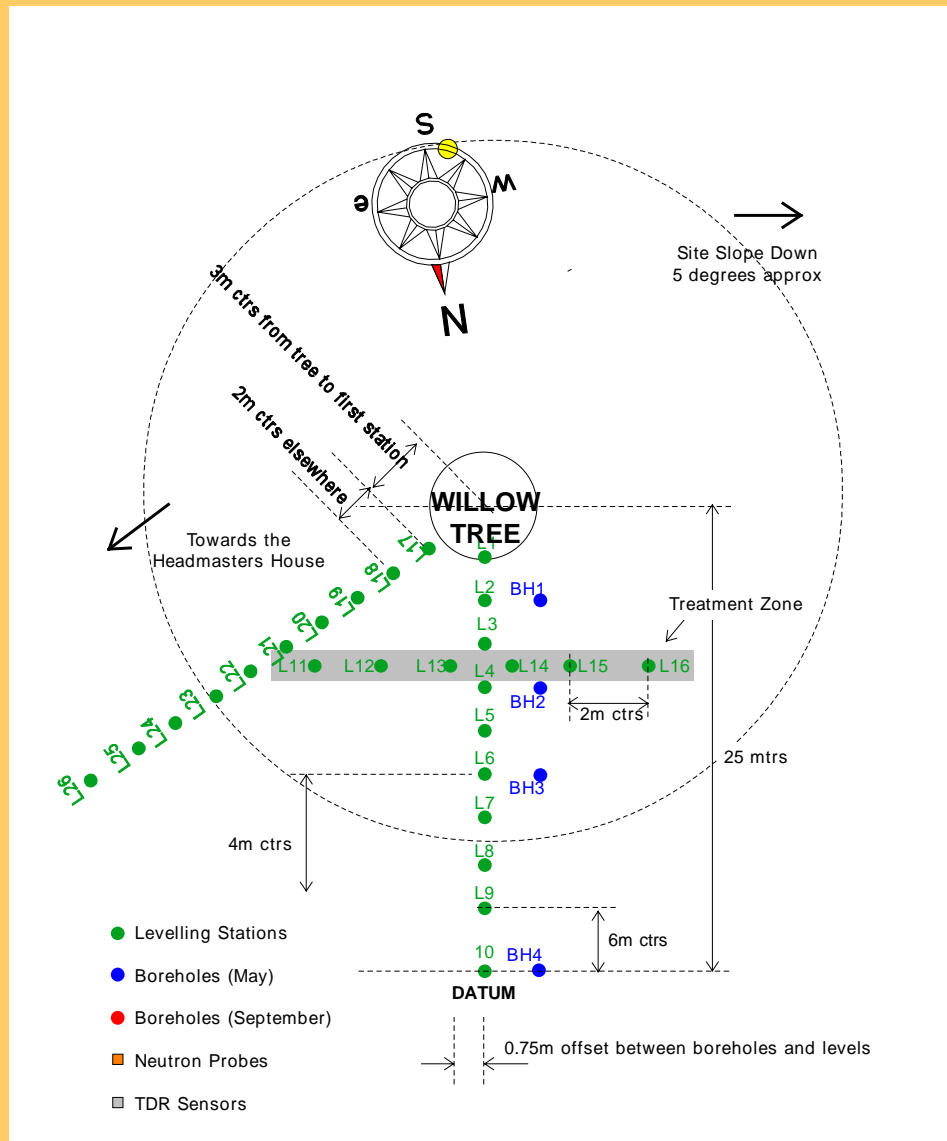
The willow occupies a gently sloping site (around 5 degrees, sloping down to the West boundary) and the instrumentation is as shown, right. Level stations 1 through to 10 (the datum) are oriented 10 degrees off the North point.

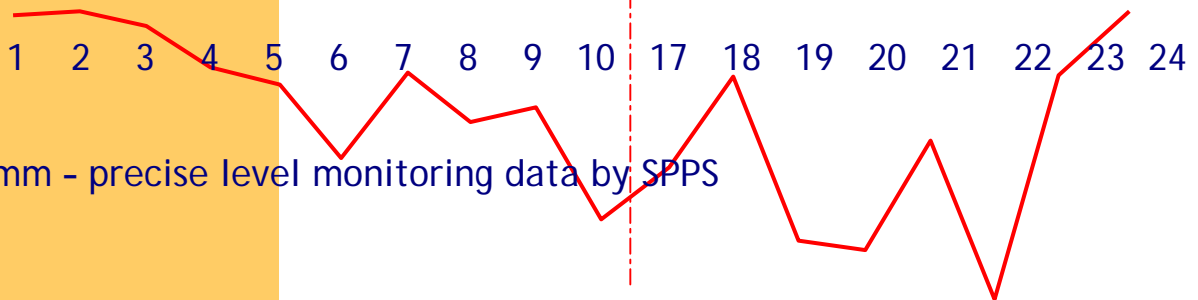
Scale - 0 - 14mm - precise level monitoring data by SPSS

The maximum movement (downward) recorded between May and June was 10.9mm at Station 20 (see plan).

Movement was significantly more along stations 17 - 25 in general (to the right of the photograph below) and more gradual and of less amplitude on the North facing array.

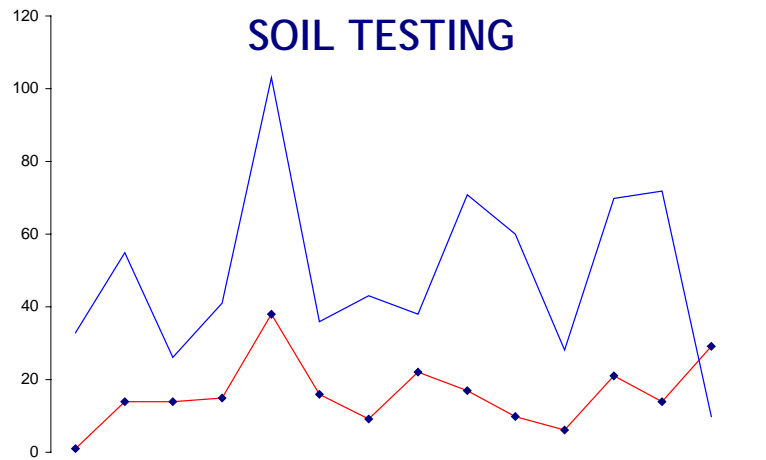
In 8% of cases the actual soils data (blue line) over-estimated the estimate of swell due to incorrect plotting of the  $K_0$  line. Here, the modelling application was probably closer to the correct values if we made the necessary adjustment. This also reflects the natural tendency for estimates based on soils data to over-estimate recovery.

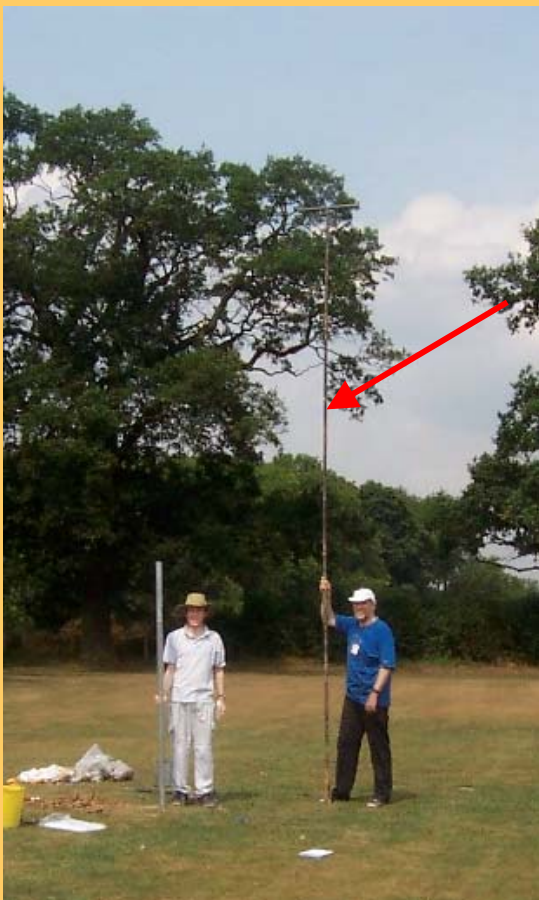
Derek threatened to call it a day if there was any suggestion of lightening. Below we see him holding the hand auger which was about 6m high as he pulled it out of the ground.

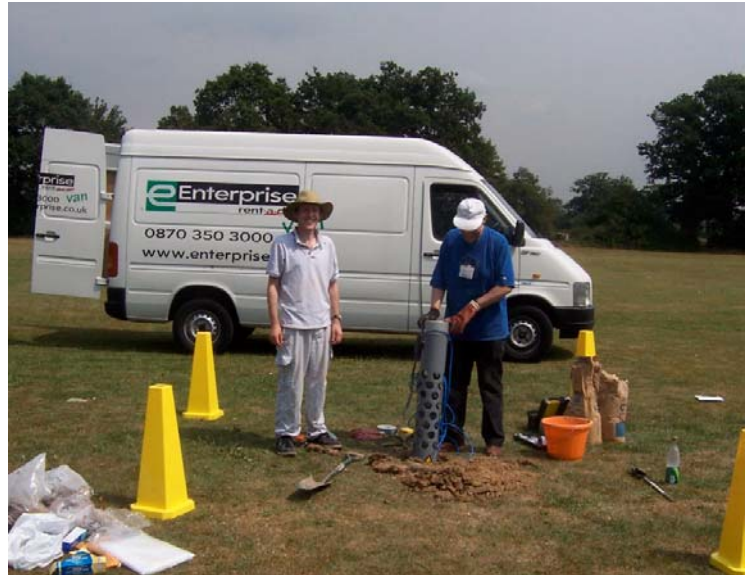
Dr's Joel Smethurst (left) and Derek Clark from Southampton rolled up their sleeves and decided to install the neutron probe tubes themselves. Despite temperatures racing nearly 28 degrees on the day, they successfully sank the hand augers to depths of 4 - 5mtrs through stiff, desiccated clay.

Above we see the yellow cones that are required as part of the Health & Safety Regulations for operating radioactive materials on site. The neutron probe is perfectly safe, as long as we comply with the Method Statement and Risk Assessment.
