# The Clay Research Group

June 2020  
Edition 181

## Aldenham Headmaster's House

## Subsidence Risk Analysis – STRATFORD-on-AVON

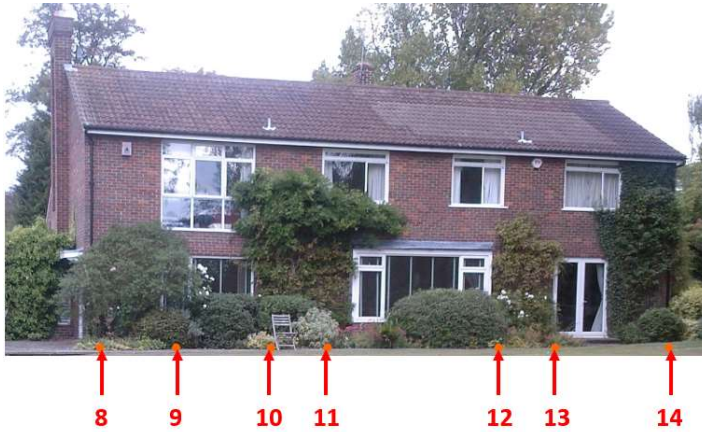
In 2009 the Headmaster’s house at Aldenham School research site developed cracks, the pattern of which indicated subsidence of the rear wall. See picture right showing the diagonal crack in the left (when viewed from rear garden) flank wall.

Left is a photograph of the rear elevation showing the location of relevant level stations and below, a site layout plan showing the location of level stations and boreholes. Several trees and shrubs have roots that would likely extend beneath the house foundations.

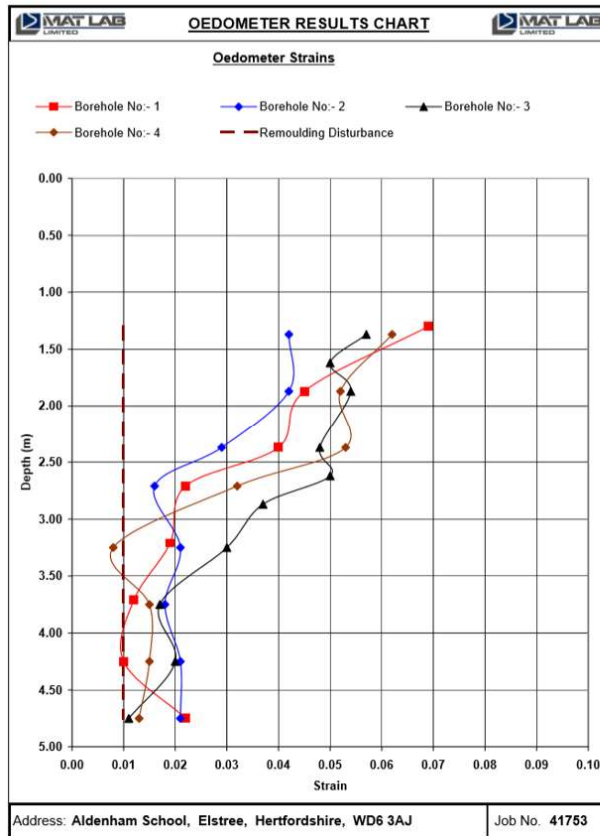
## Soil Tests – Penetrometer -v- Oedometer.

Site investigations revealed a desiccated clay and results using the penetrometer were similar to oedometer strains - see below. The profiles from all bores and tests (including suction profiles – see following page) delivered similar profiles. The clay soils were desiccated to depths of around 3mtrs.

Estimates of heave based on the oedometer tests are as follows: BH1 = 46mm, BH2 = 34mm, BH3 = 53mm and BH4 = 47mm.

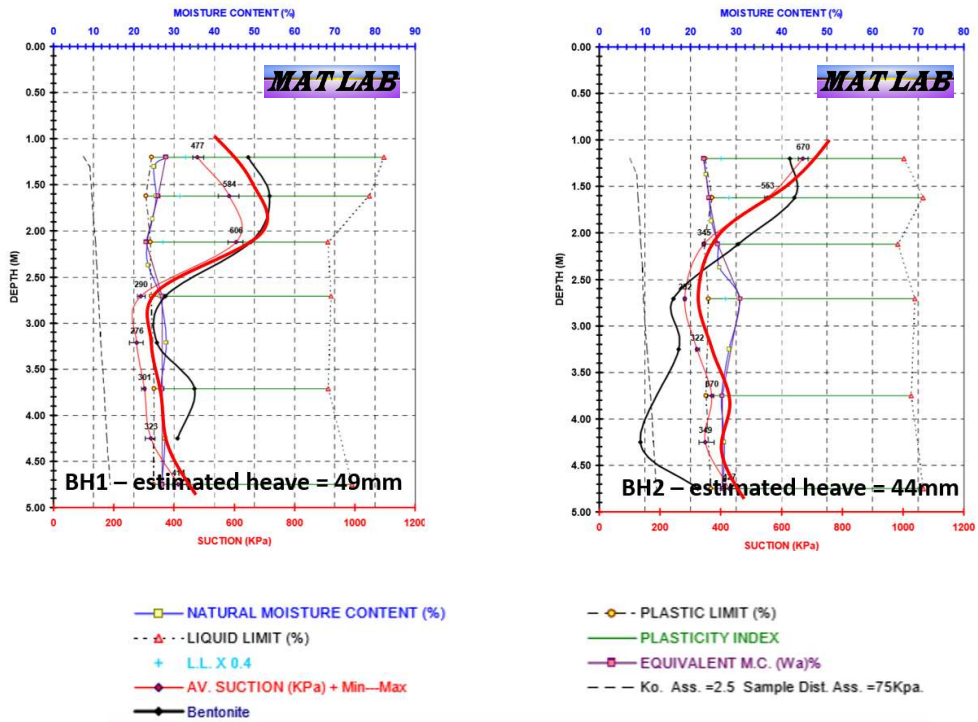
## Soil Suctions

Below, suction profiles, moistures and PI values for the four boreholes shown on page 2. Those against the rear house wall indicated a potential swell in the range 44 – 49mm.

The bore sunk in the rear garden (BH3) had an estimated swell potential of 61mm, which is likely to include a significant contribution from the peripheral roots of the willow.

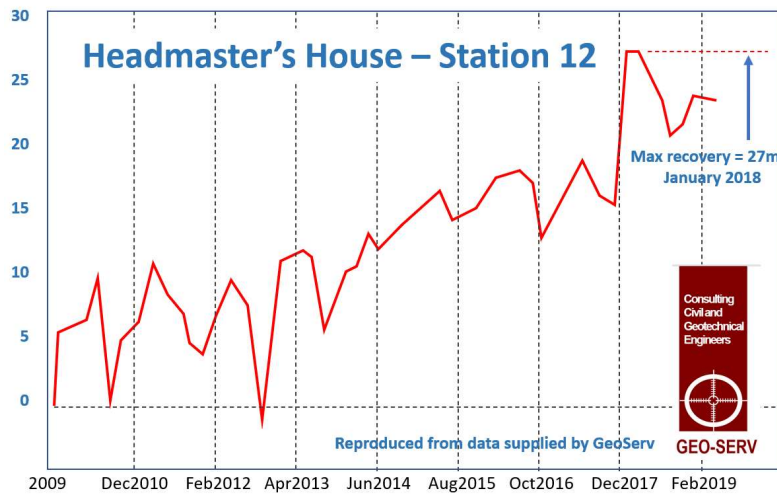
There was no evidence that the minor leakage from nearby drains was an influencing factor. First, the ground was dry when trial holes were excavated and second, the evidence of desiccation down to 3mtrs or so suggests otherwise – as does the recovery profile. See monitoring graph for station 12 below.

Estimates of swell from soil testing suggests a potential recovery of over 40 – 50mm. Actual recovery over a 10 year term has been 27mm maximum at station 12 (above).

The potential influence of peripheral roots from the willow confound a conclusive answer as to whether the estimate of swell is ‘accurate’ and particularly as we know there is a persistent moisture deficit at the root periphery of the willow and 108mm subsidence was recorded at station 25 in September 2019. Perhaps the potential for a further 20mm or so of recovery remains due to the moisture uptake of the trees but for the time being, action with the shrubs has resolved the problem.

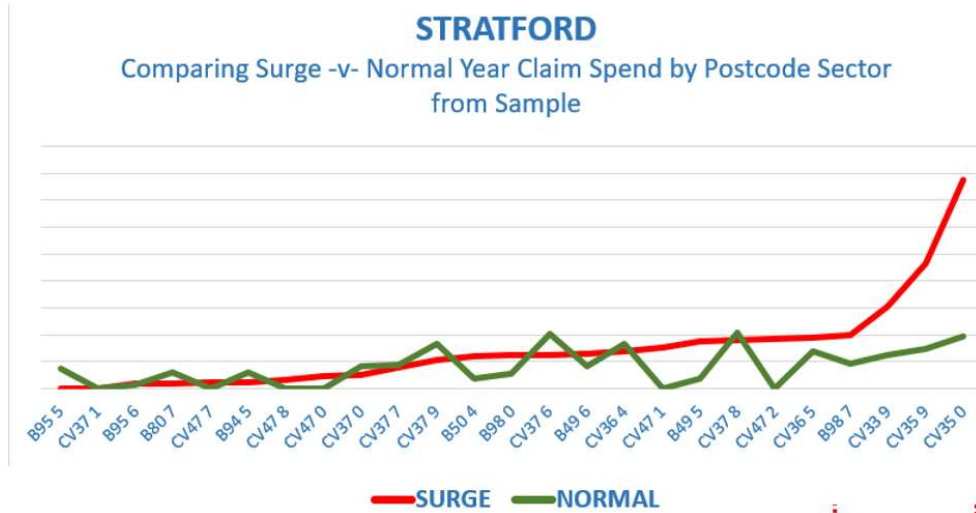
*Sectors most at risk at times of surge*

Identifying the variable risk across the district distinguishing between normal and surge years by postcode sector. Divergence between the plots indicates those sectors most at risk at times of surge (red line).
